NAVAL AVIATION SAFETY CENTER

1. The accident occurred at NAS Miramar at 2131 12 August 1963. This field incorporates two parallel runways, the right runway (24R) 12,000 feet long, and the left runway (24L), 8,000 feet long. A left hand traffic pattern is used on both runways with altitude differential providing aircraft separation. Prior to the accident the field had been operating under VFR conditions with MLP in progress on runway 24L and all other traffic being handled on 24R. At approximately 2118, a low cloud layer (500 feet) started moving across the field from the west causing tower personnel to lose sight of aircraft on the crosswind and downwind legs of the pattern. Action was taken to set the field IFR, and the LSO was directed to terminate MLP and land his aircraft on runway 24L.

VF-114 SER I-63A/VF-96 SER 4-63A, INVOLVING F4B BUNO 148391 AND  
F4B BUNO 150645, PILOTS [REDACTED] (b) (6)

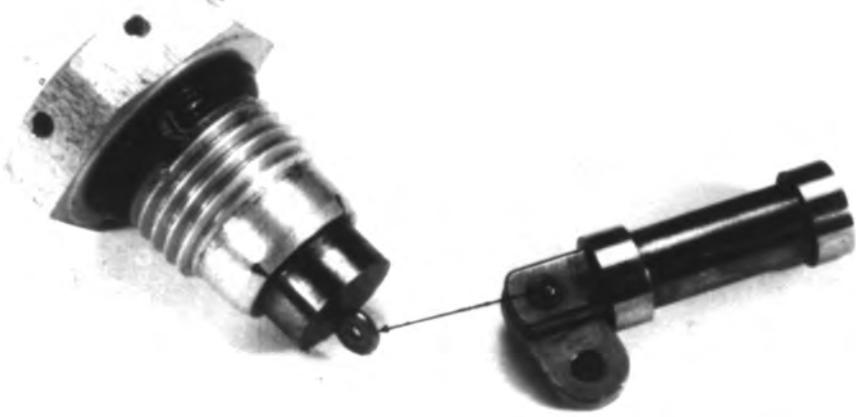
NOZZLE AREA PUMP  
P/N 512D866P1  
ENG. MOD. J79-GE8  
SERIAL NO. 401463  
SEQ. NO. 5-284  
ENCLOSURE (1)

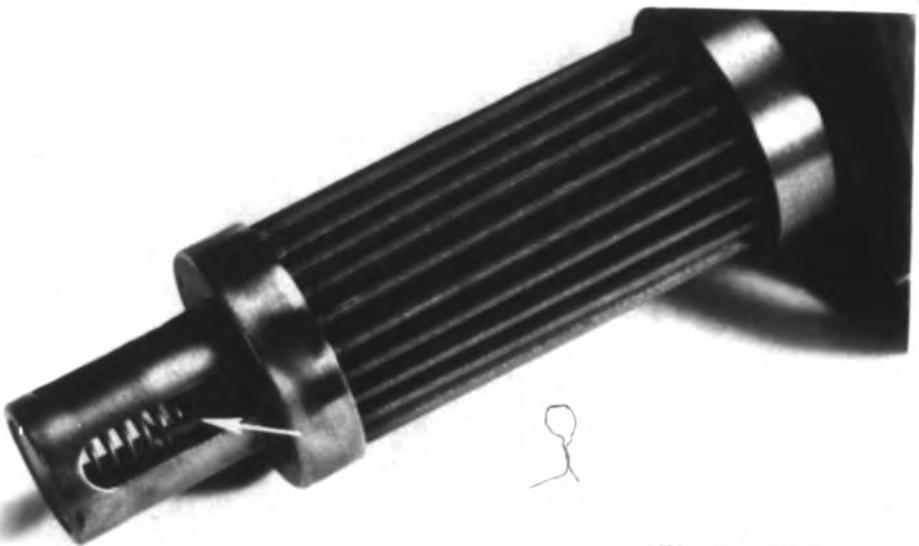
NOZZLE AREA CONTROL  
P/N 512D715P3  
S/N 5395588  
ENG. MOD. J79-GE8  
SEQ. NO. 5-285  
ENCLOSURE (2)

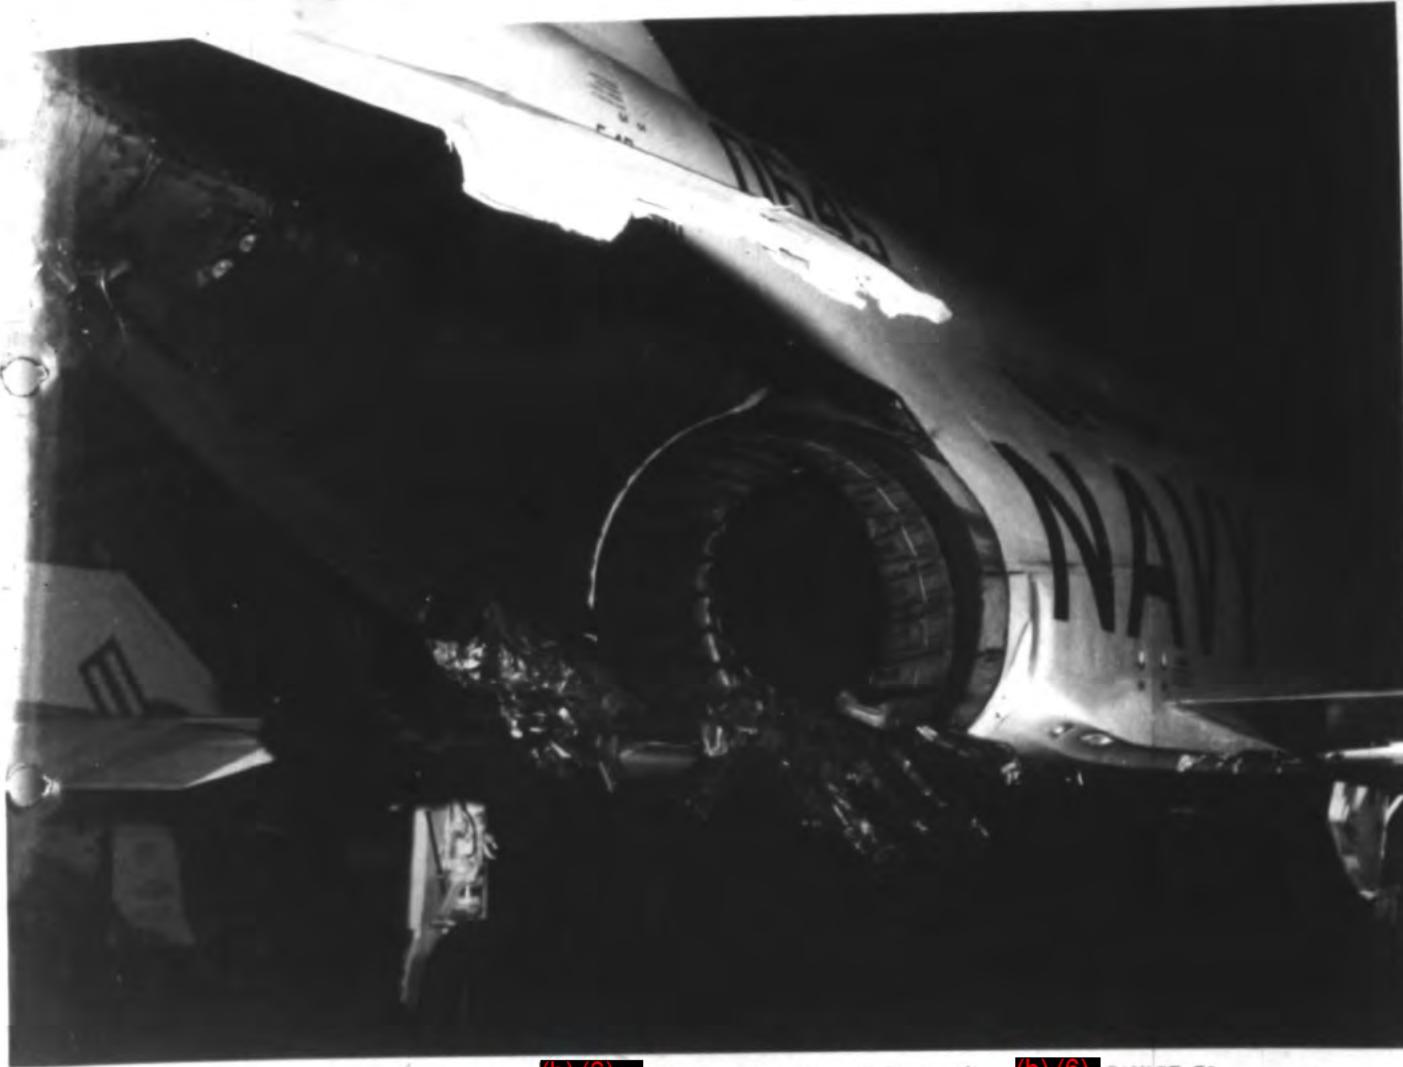
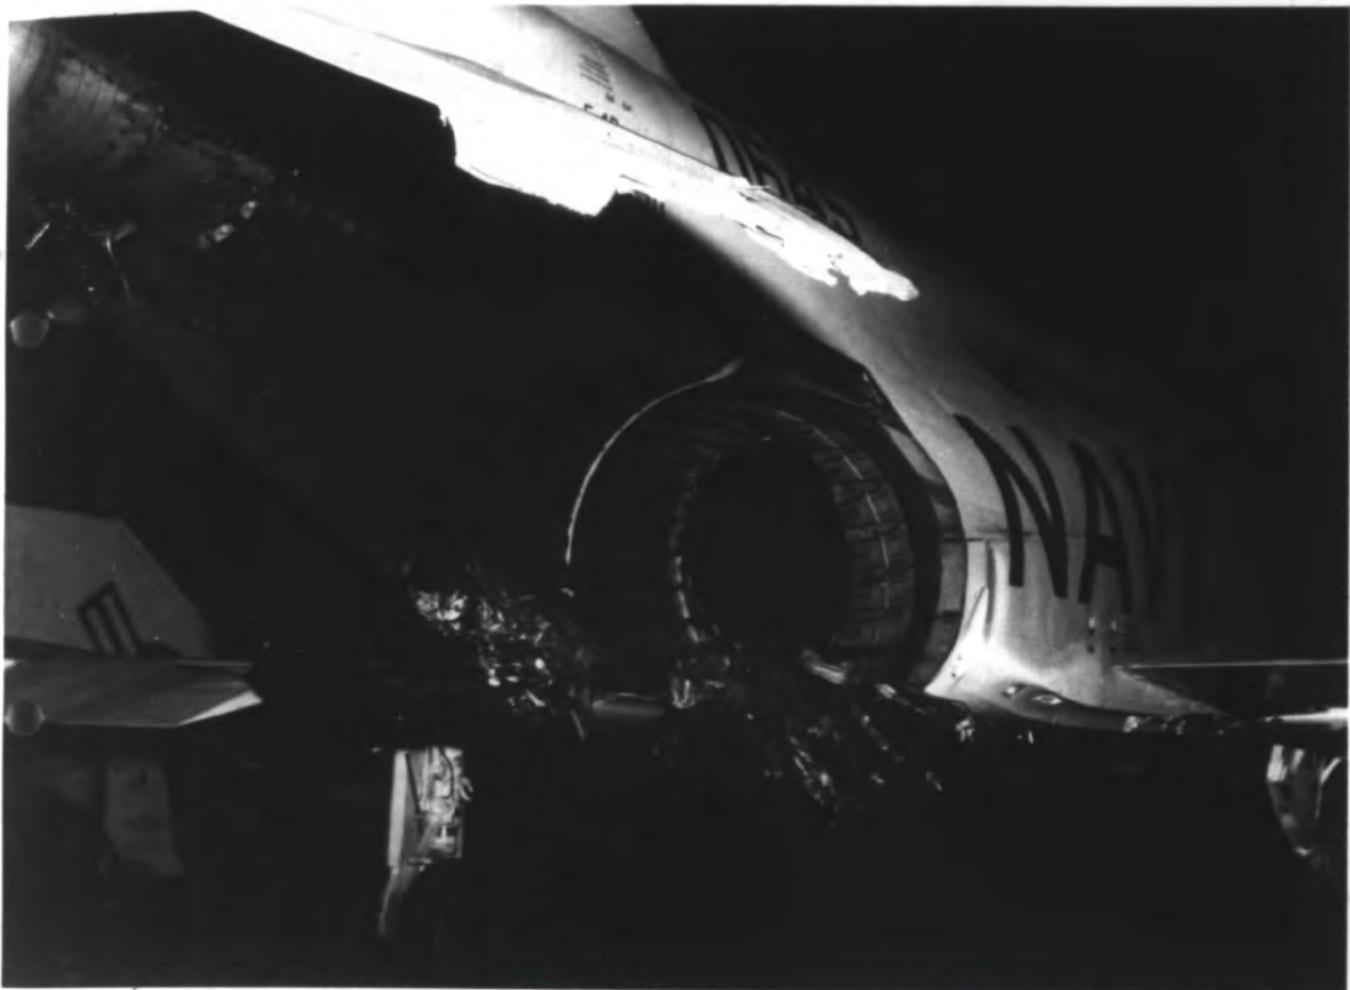
- (1) Left and right aluminum honeycomb section of stabilator ripped.
  - (2) Stabilator actuator damaged and stabilator attachment fittings (fuselage mounted fractured); stress plate between attach fittings ripped.

- (3) Clevis tie down fitting damaged.
  - (4) Arresting gear fairing destroyed and arresting gear shank damaged.
  - (5) Variable nozzles damaged on both afterburner duct assemblies.

VF-114, SER 1-634, F4B, 148391 (b) (6) VF-96, SER 4-63A, F4B, 150645, (b) (6) DAMAGE TO  
F4B 150645 TAIL HOOK, AFTER ENGINE SECTION, AND STABILATOR. SPECIAL HANDLING REQUIRED  
IN ACCORDANCE WITH P.R. 66, OPNAVINST P3750.6E. ENCLOSURE (1A)

VF-114, SER 1-63, F4B, 148391 (b) (6) VF-96, SER 4-63A, F4B, 150645, (b) (6) DAMAGE TO  
F4B 150645 TAIL HOOK, AFTER ENGINE SECTION, AND STABILATOR. SPECIAL HANDLING REQUIRED  
IN ACCORDANCE WITH PARA 66, OPNAVINST P3750.6E. ENCLOSURE (IA)

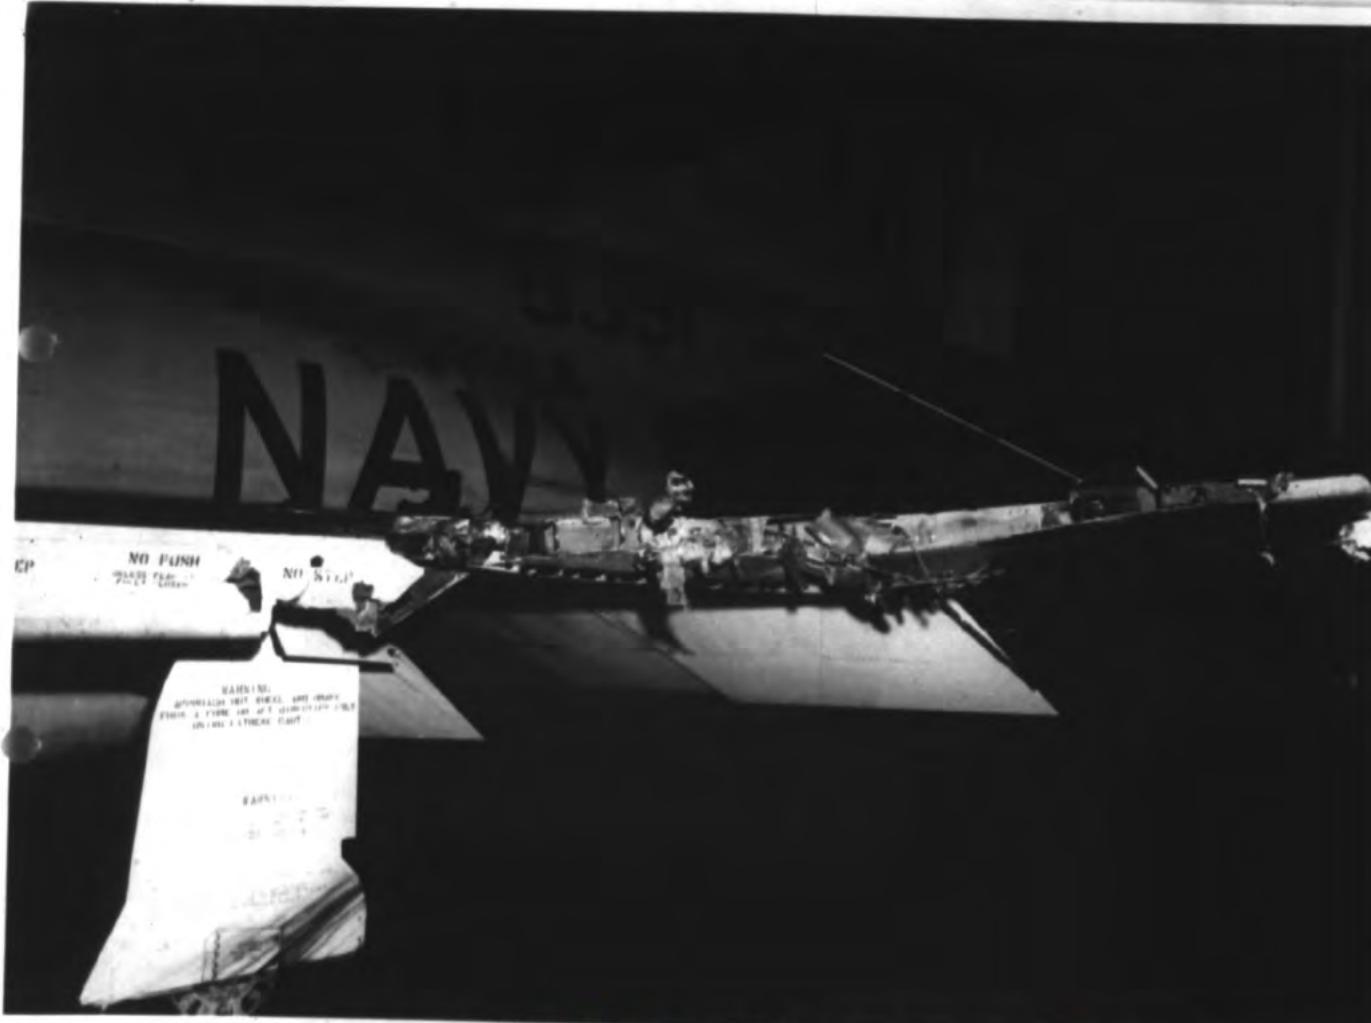
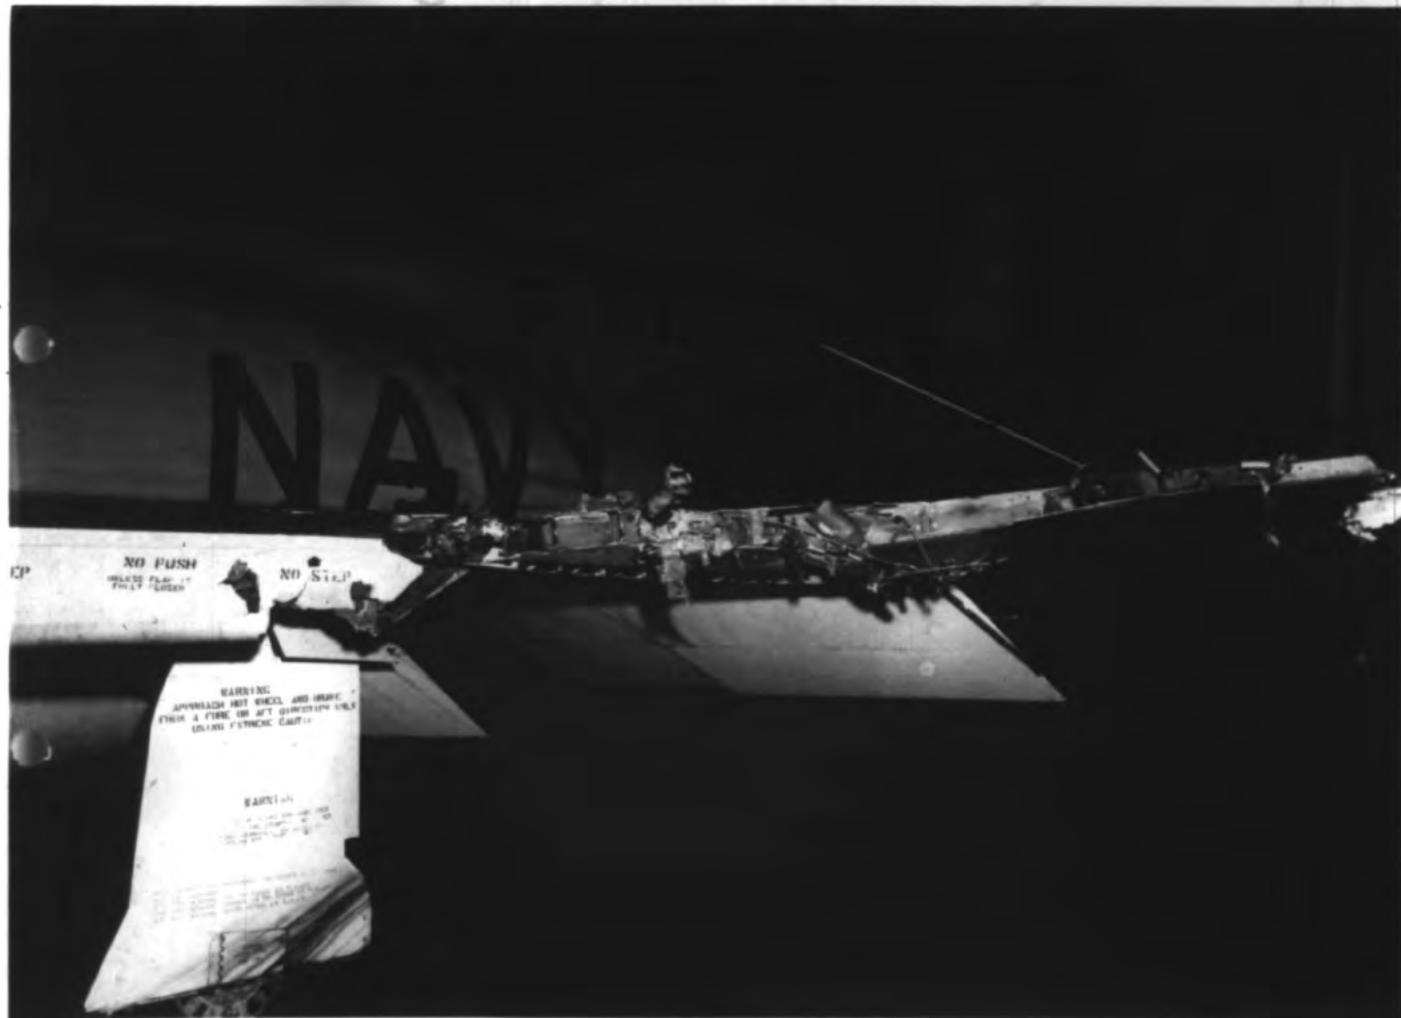
- E. Left fuselage ruptured about F.S. 414.
- (1) Door 47L and fuselage ruptured through to engine cavity.
  - (2) Fuselage tear F.S. 426 through F. S. 453.30.

VF-114, SER 1-63A, F4B, 148391, (b) (6) VF-96, SER 4-63A, F4B, 150645, (b) (6) PORT  
OUTER WING PANEL AND FUSELAGE DAMAGE TO F4B 148391 SPECIAL HANDLING REQUIRED IN  
ACCORDANCE WITH PARA 66, OPNAVINST P3750.6E. ENCLOSURE (18)

VF-114, SER 1-63A, F4B, 148391, (b) (6) VF-96, SER 4-63A, F4B, 150645, (b) (6) PORT  
OUTER WING PANEL AND FUSELAGE DAMAGE TO F4B 148391 SPECIAL HANDLING REQUIRED IN  
ACCORDANCE WITH PARA 66, OPNAVINST P3750.6E. ENCLOSURE (16)

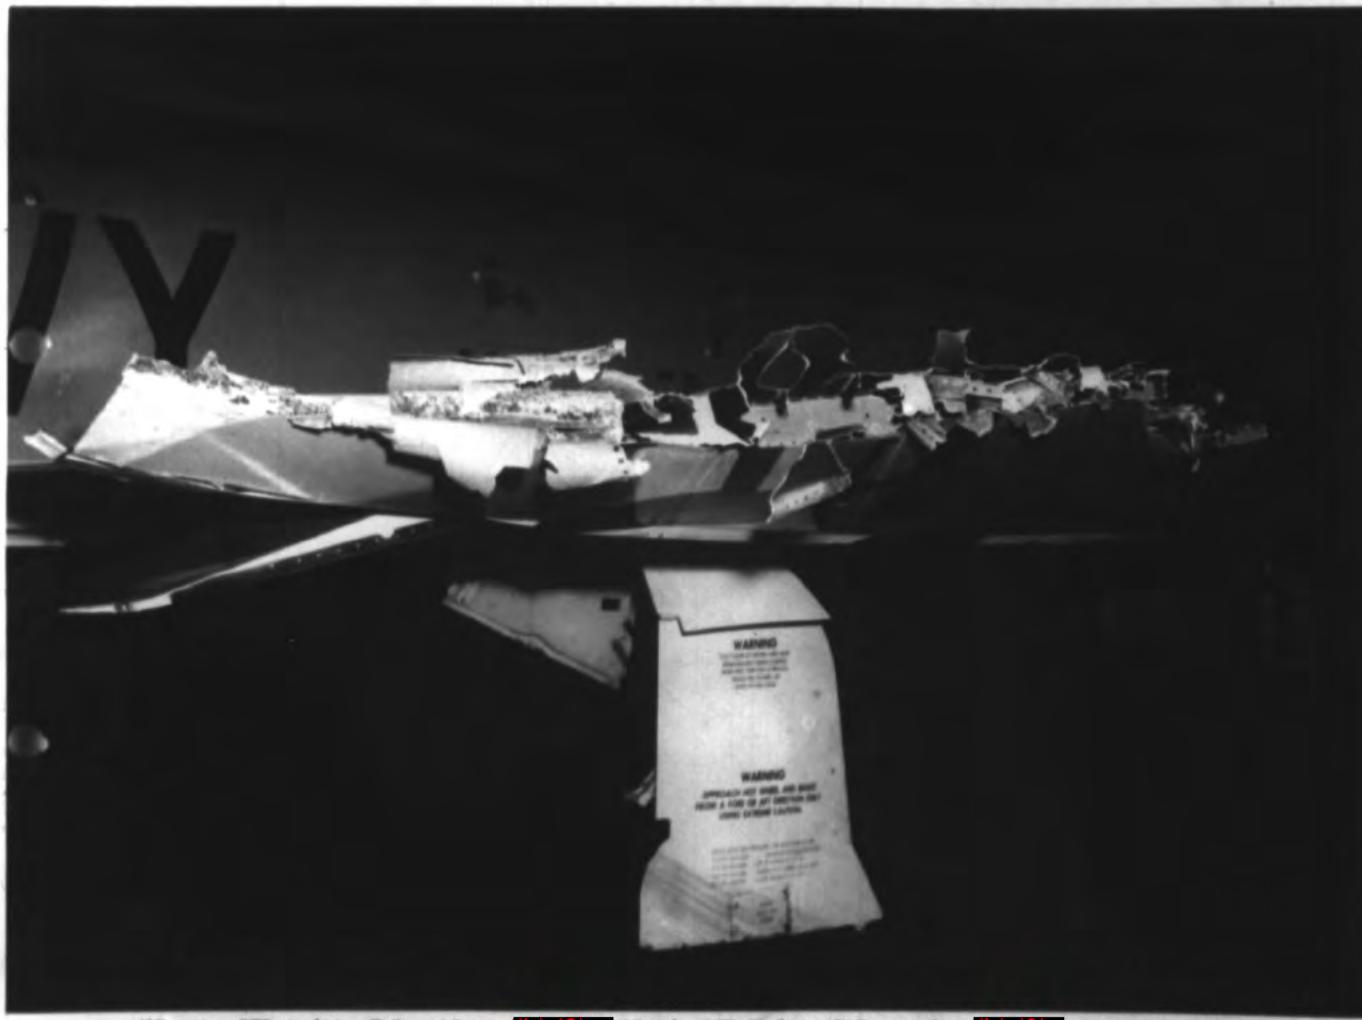
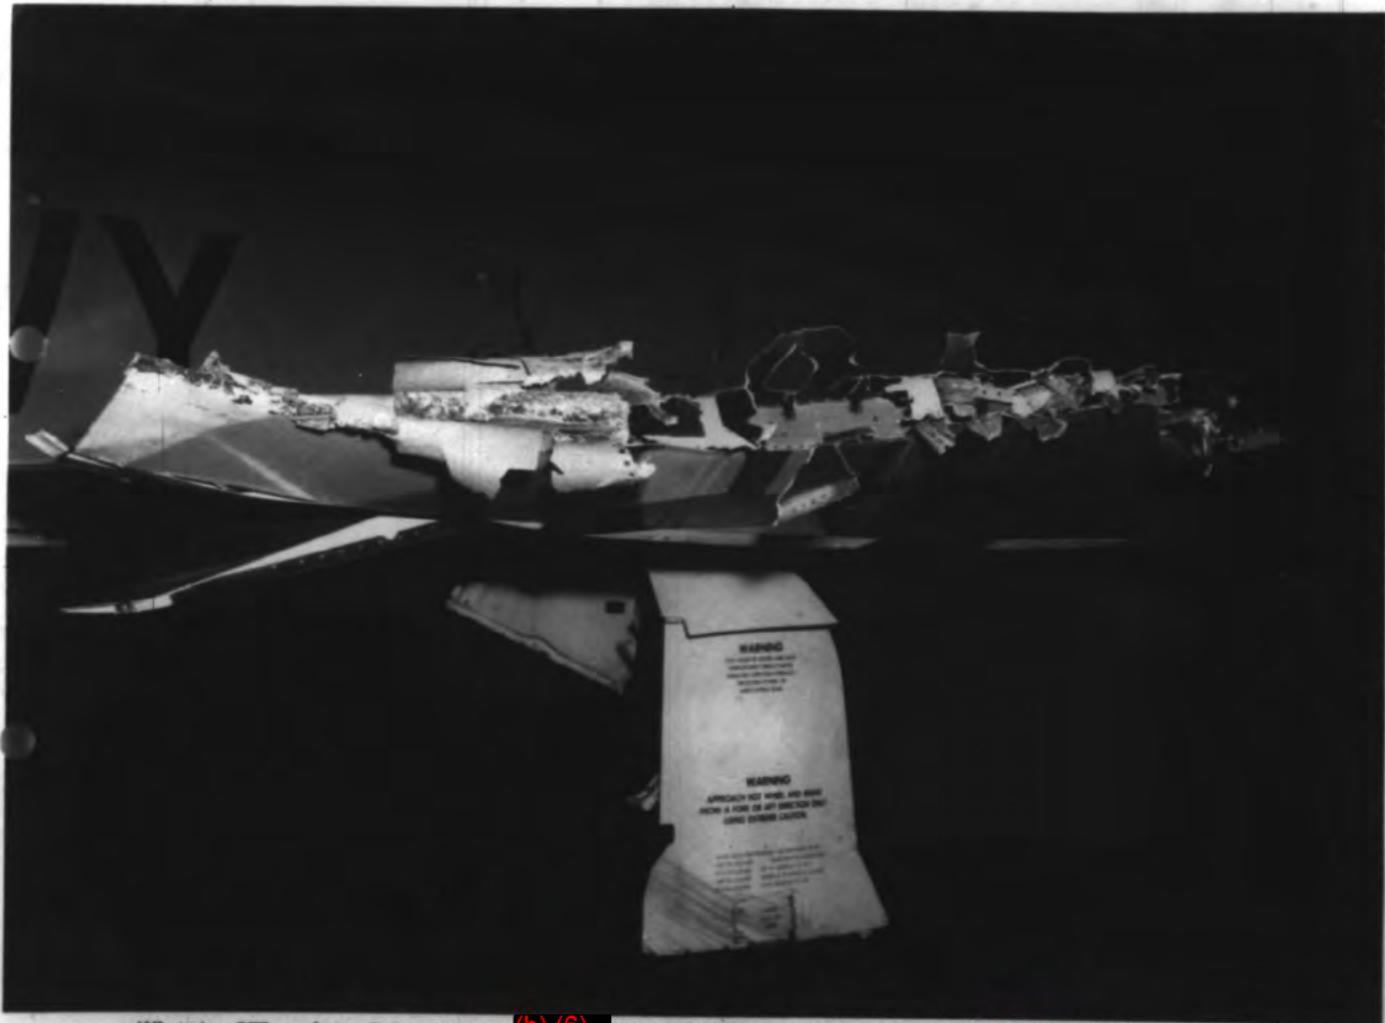
- (6) Engine access door (96R) torn.
  - (7) Arresting gear dampers damaged.
- B. Starboard wing damage.
- (1) Right fuel dump mast destroyed.
  - (2) Right aileron damaged.

VF-114, SER 1-63A, F4B, 148391, (b) (6) VF-96, SER 4-63A, F4B, 150645, (b) (6) STARBOARD  
OUTER WING DAMAGE TO F4B 150645 SPECIAL HANDLING REQUIRED IN ACCORDANCE WITH PARA 66,  
OPNAVINST P3750.5E ENCLOSURE (1C)

VF-114, SER 1-63A, F4B, 148391, (b) (6) VF-96, SER 4-63A, F4B, 150645, (b) (6) STARBOARD  
OUTER WING DAMAGE TO F4B 150645 SPECIAL HANDLING REQUIRED IN ACCORDANCE WITH PARA 66,  
OPNAVINST P3750.6E ENCLOSURE (1C)

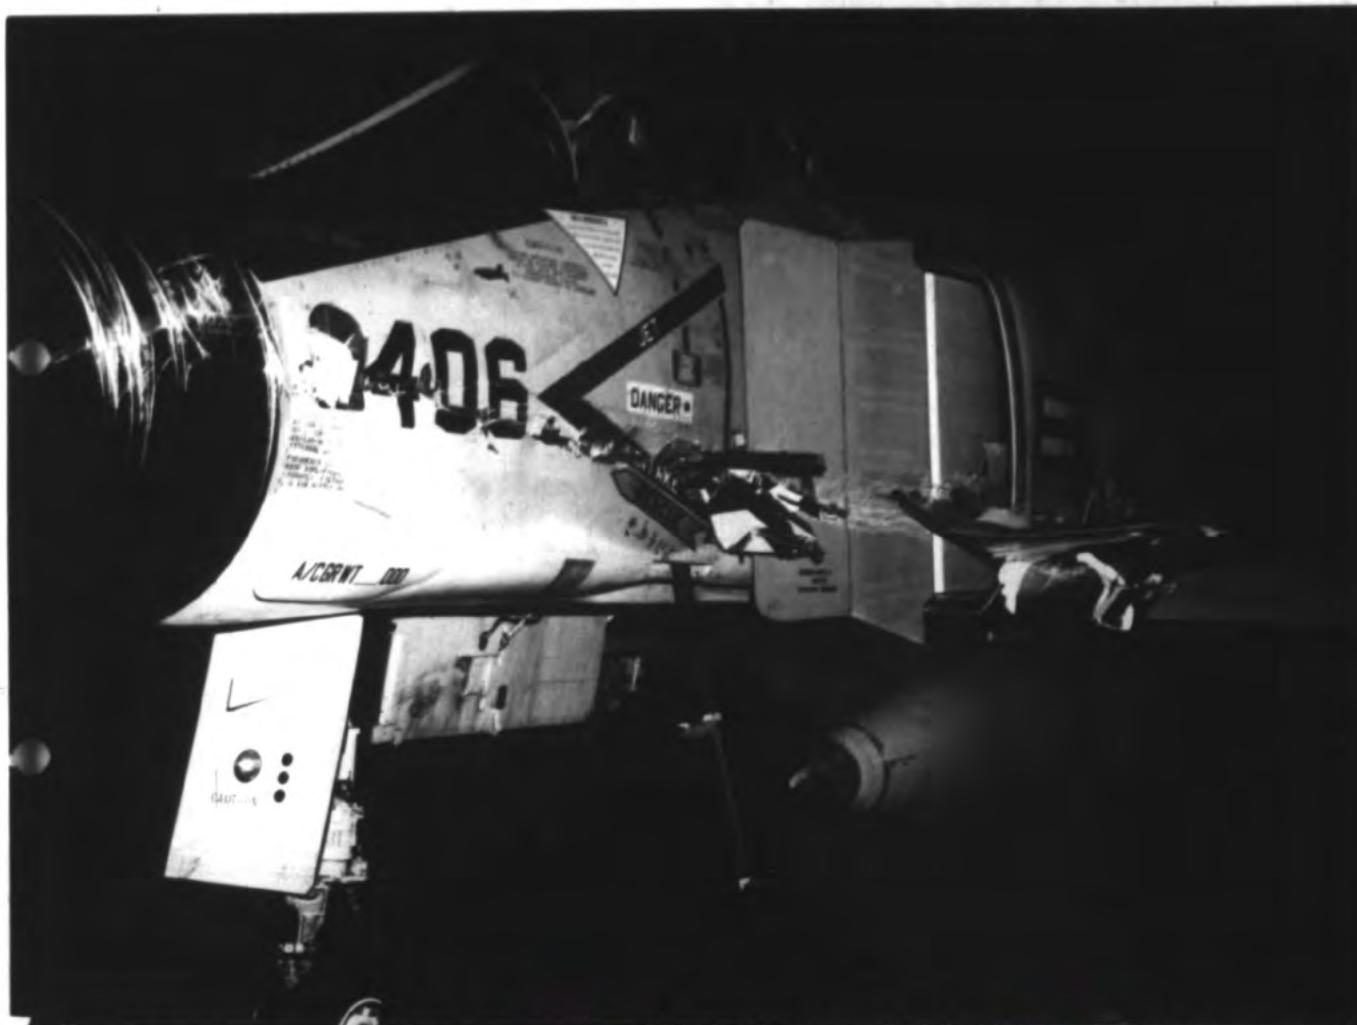
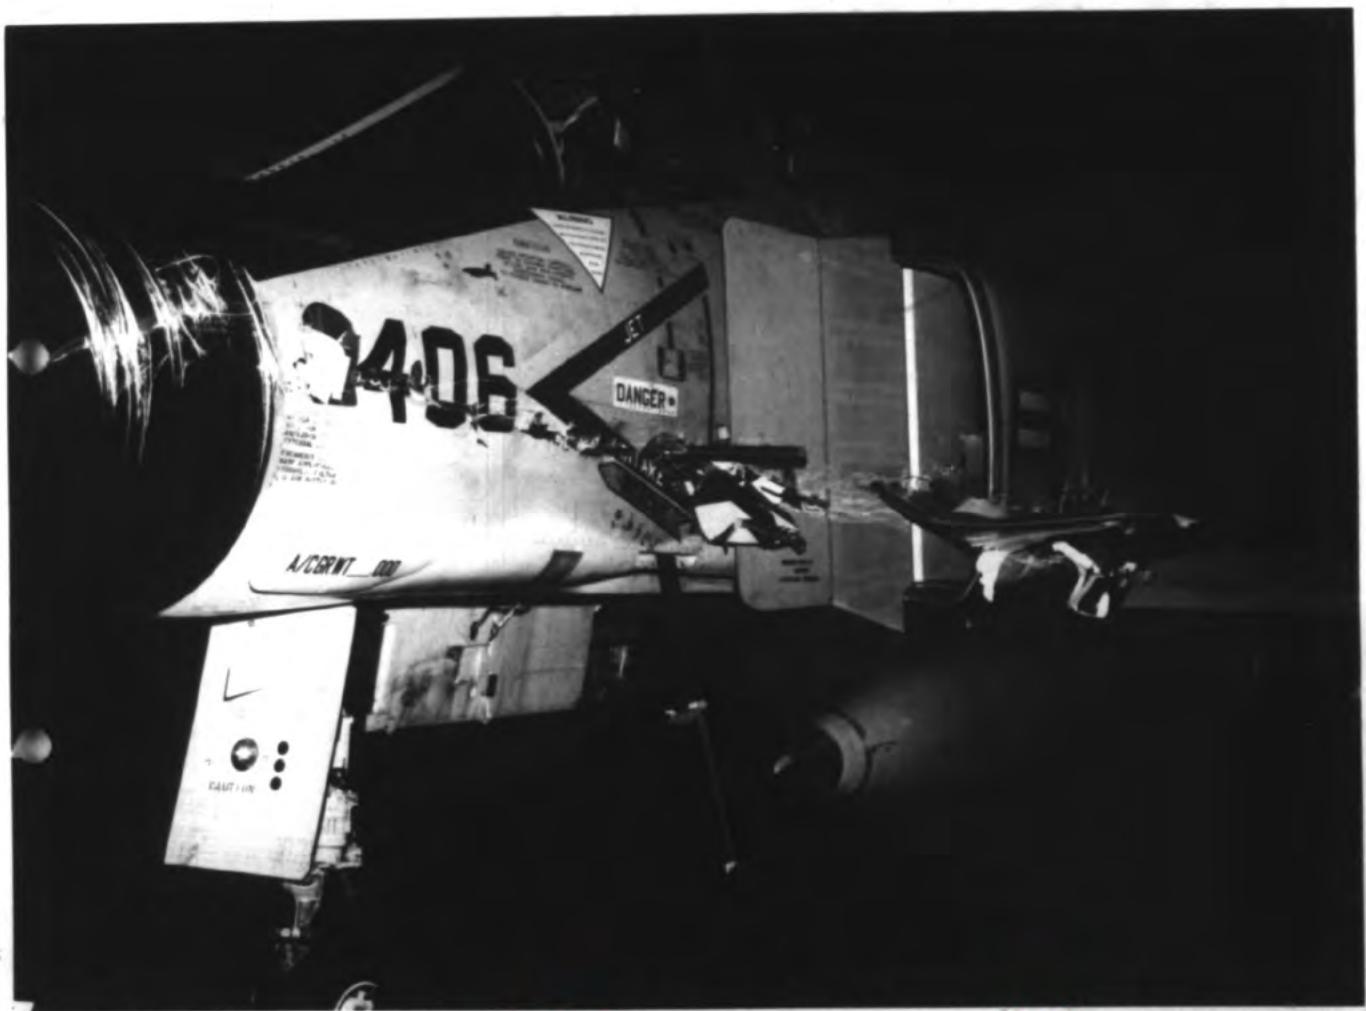
VF-114, SER 1-<sup>2</sup>, F4B, 148391, (b) (6) VF-96, SER 4-63A, F4B, 150645, (b) (6) FUSELAGE  
AND WING DAMAGE TO F4B 148391 SPECIAL HANDLING REQUIRED IN ACCORDANCE WITH PARA 66,  
OPINVNGT P0750.6E ENCLOSURE (I-D)

VF-114, SER I-~~31~~, F4B, 148391, (b) (6) VF-96, SER 4-63A, F4B, 150645, (b) (6) FUSELAGE  
AND WING DAMAGE TO F4B 148391 SPECIAL HANDLING REQUIRED IN ACCORDANCE WITH PARA 66,  
OPNAVINST P3750.6E ENCLOSURE (1-D)

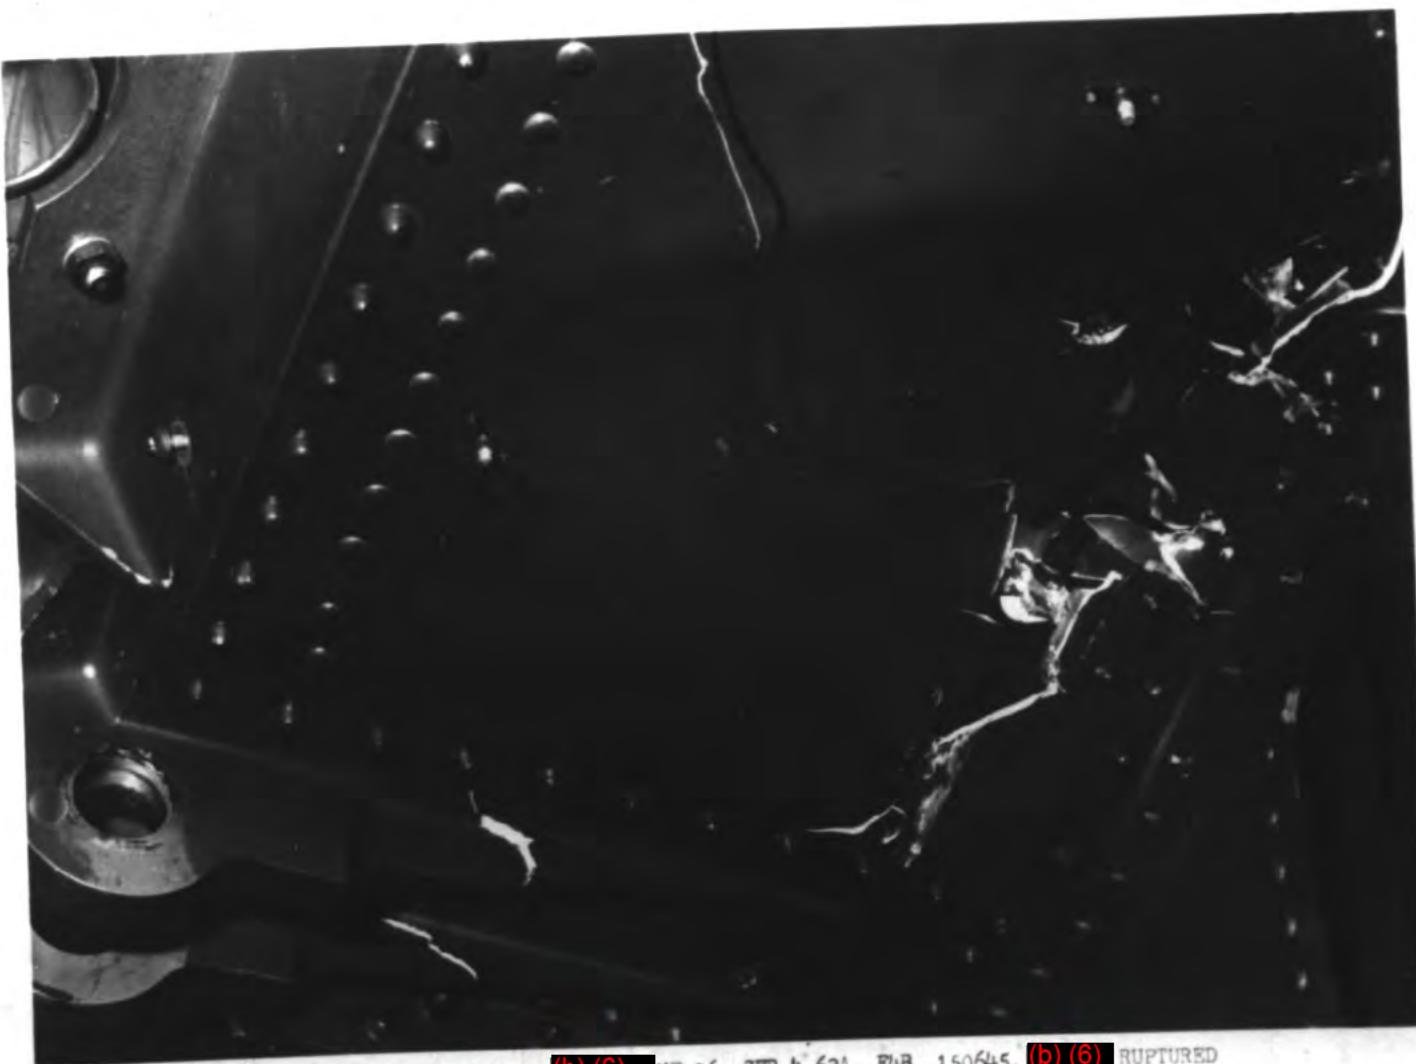
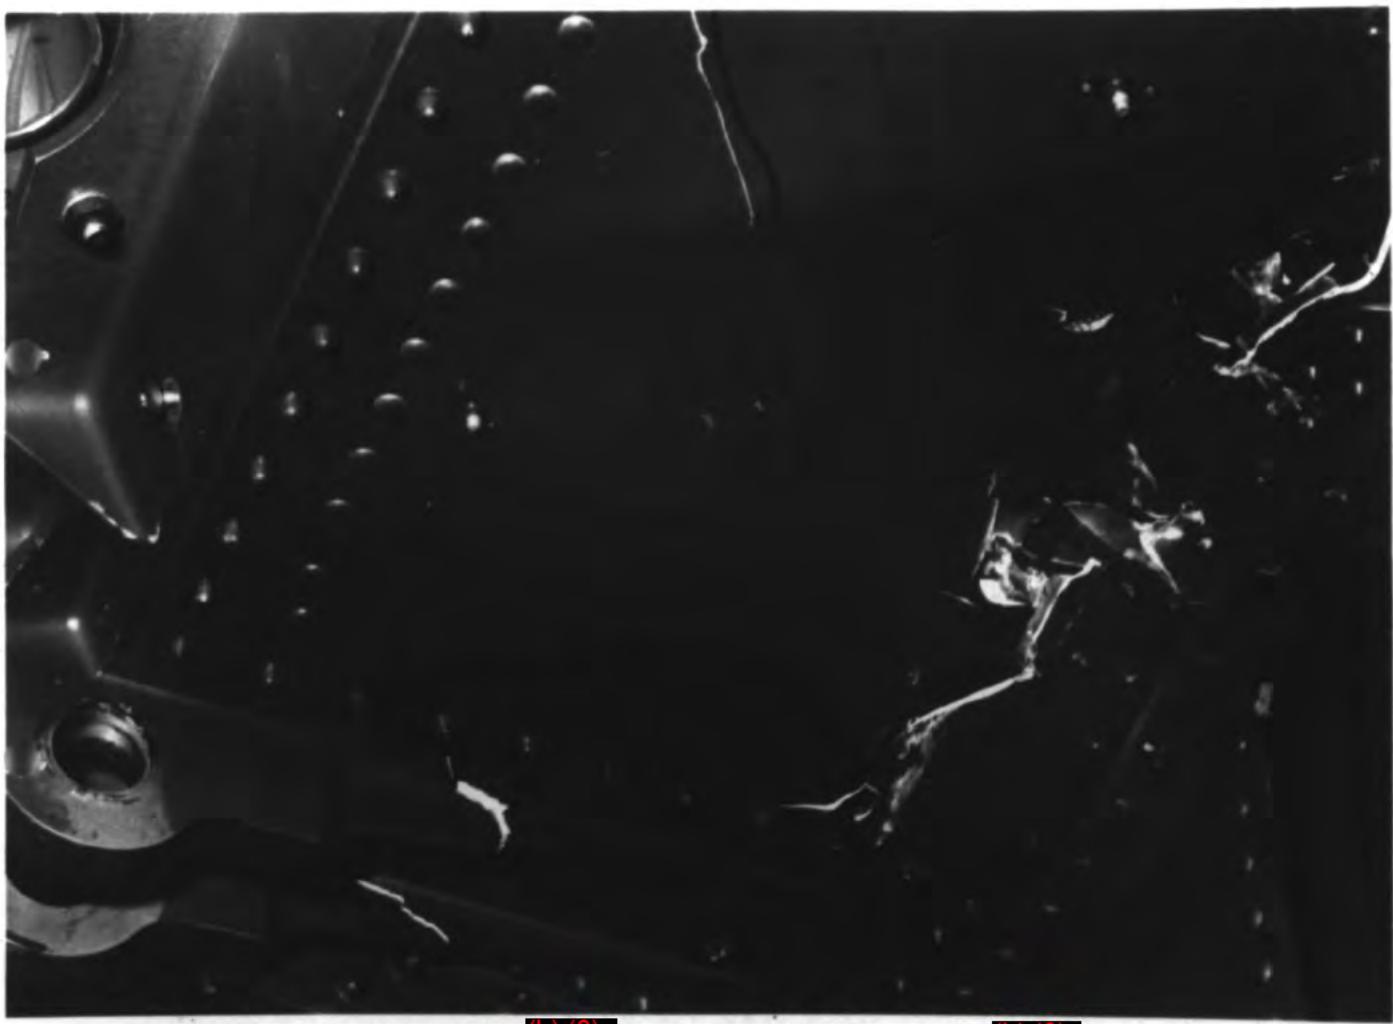
VF-114, SER 1-63A, F4B, 148391, (b) (6) VF-96, SER b-63A, F4B, 150645, (b) (6) RUPTURED  
STRESS PLATE FS 613.44 TO FS 600.00 AND FRACTURED STABILATOR ATTACH POINTS ON F4B  
150645. SPECIAL HANDLING REQUIRED IN ACCORDANCE WITH PARA 66, OPNAVINST P3750.6E.  
ENCLOSURE (1E)

VF-114, SER 1-63A, F4B, 148391, (b) (6) VF-96, SER 1-63A, F4B, 150645, (b) (6) RUPTURED  
STRESS PLATE FS 613.44 TO FS 600.00 AND FRACTURED STABILATOR ATTACH POINTS ON F4B  
150645. SPECIAL HANDLING REQUIRED IN ACCORDANCE WITH PARA 66, OPNAVINST P3750.6E.  
ENCLOSURE (1E)

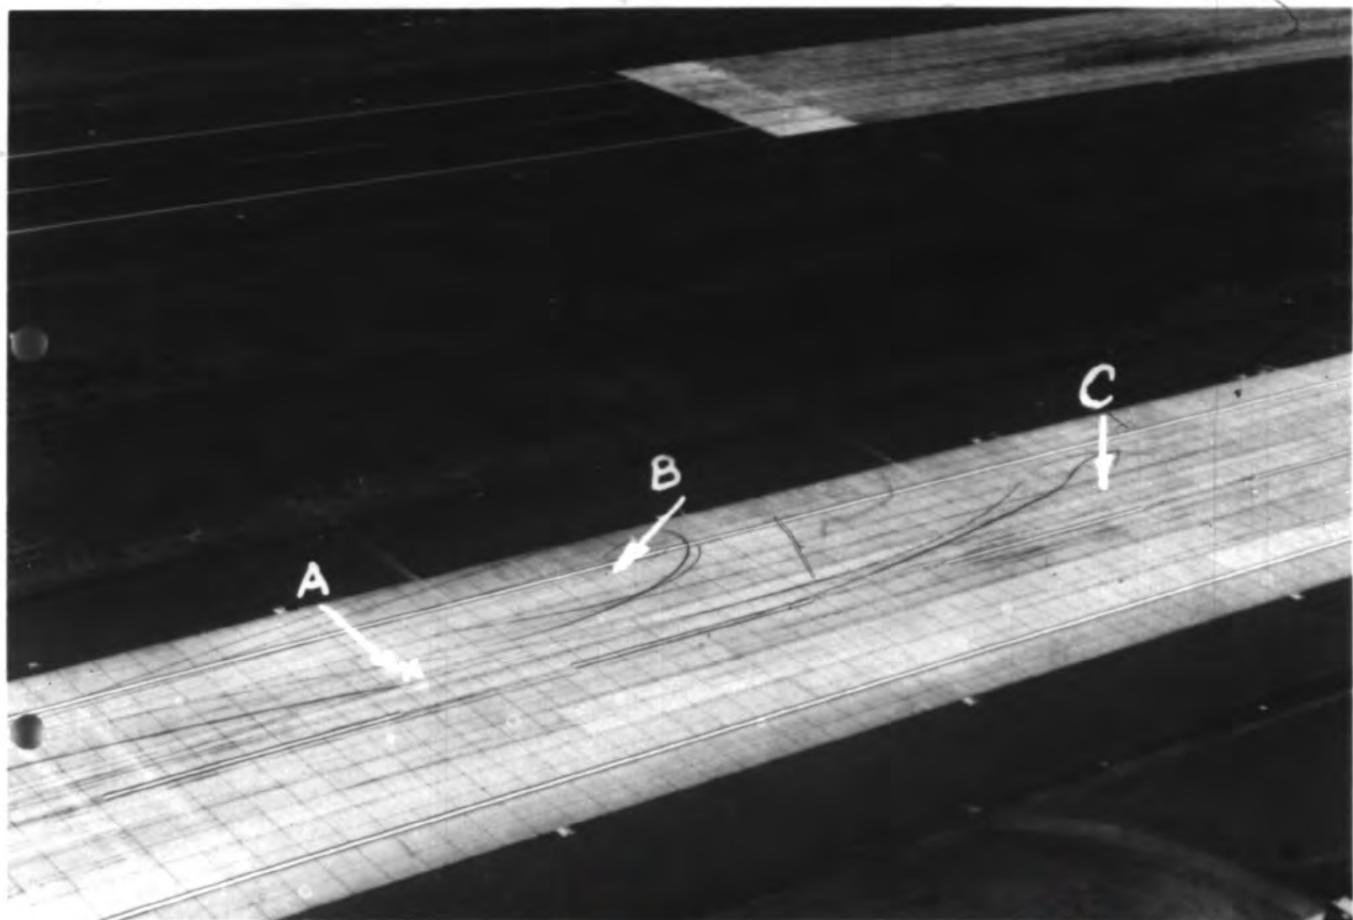
VF-114, SER 1-63A, F4B, 148391, (b) (6) VF-96, SER 4-63A, F4B, 150645, (b) (6)  
PHOTOGRAPH SHOWING SKID MARKS ON RUNWAY 24R NAS MIRAMAR. COLLISION OCCURRED  
AT APPROXIMATELY 6260 FT FROM APPROACH END. A-IMPACT POINT, B-FINAL POSITION  
F4B BUNO 150645, C-FINAL POSITION F4B BUNO 148391. SPECIAL HANDLING REQUIRED  
IN ACCORDANCE WITH PARA 66, OPNAVINST P3750.6E. ENCLOSURE (16)
